**HISTORIC RESOURCES INVENTORY:**  
 Buildings & Structures

**SURVEY OF GUILFORD, NEW HAVEN COUNTY, 06437**  
 June-December 1981

1. **ADDRESS** 2479 Long Hill Road  
(map 101, lot 18)
2. **NAME**  
(historic) Possibly Stephen Fowler  
**NAME**  
(common)
3. **USE**  
(historic)  
**USE**  
(present) Private house
4. **IF MOVED, WHEN AND FROM WHERE:**

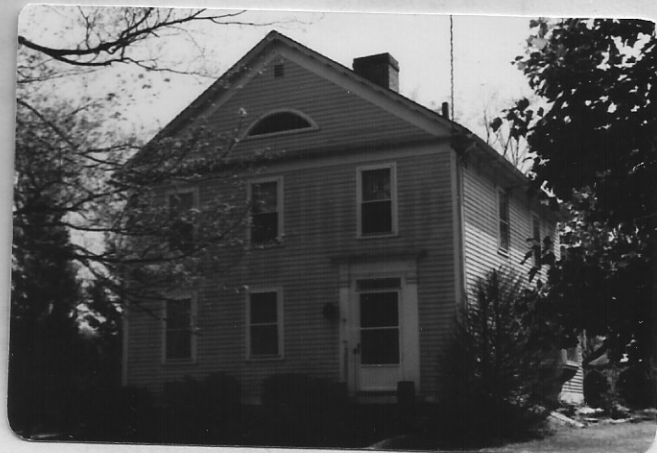
5. **ARCHITECT**
6. **DATE** Probably c 1835
- BUILDER**  
**STYLE** Federal
7. **ALTERATIONS**  
Side bay windows.
8. **NOTABLE FEATURES** Pedimented cornice; mutules and guttae decorate the eaves and raking; curved fanlight in the gable; 12/12 sash; doorway with thin tapered pilasters, bosses, mutules and guttae and a four pane transom; dressed granite block foundation (no mortar used).

9. **ARCHITECTURAL-HISTORICAL**  
 The trim along the eaves and gable of this house as well as its doorway are elements of the style of the Federal period. Its placement with its gable end toward the street is more typical of the later Greek Revival. The combination of features make it an interesting example of stylistic transition.
