HISTORIC RESOURCES INVENTORY:
Buildings & Structures

SURVEY OF GUILFORD, NEW HAVEN COUNTY, 06437
June-December 1981

1. ADDRESS 249 Long Hill Road
(map 52, lot 1)
2. NAME
(historic) Stephen Hall
NAME
(common)
3. USE
(historic)
USE
(present) Private house, apartment
4. IF MOVED, WHEN AND FROM WHERE:

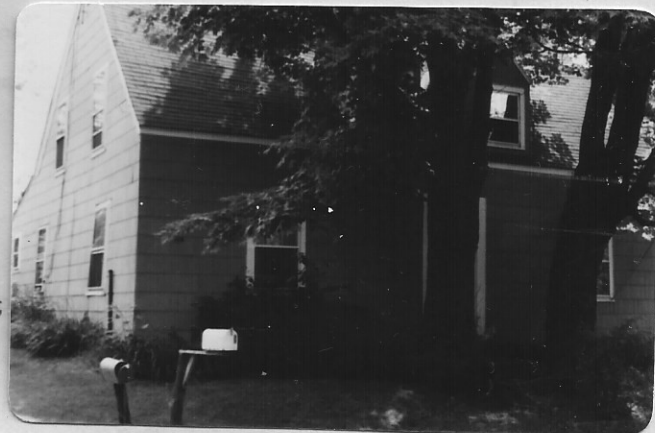
GLFD'S NEG. 23:20

5. ARCHITECT
6. DATE 1770 BUILDER STYLE Colonial
7. ALTERATIONS
Dormers; siding; 6/6 sash; chimney; shed roof addition in rear (Old).
8. NOTABLE FEATURES
Doorway with a plain frame; a six pane transom, and an old four panel door; stone foundation.

9. ARCHITECTURAL-HISTORICAL
An old door in a plain doorway with small transom lights emphasize the simplicity of this house, the facade of which is completed by a window on either side of the door. The dormers are modern additions to this small story-and-a-half house.
The original owner Stephen Hall may have been Captain Hall who served in Gen. Wooster's Regiment 1775-76 (deceased in 1783) or Ensign Stephen Hall who served 12 days following the Battle of Lexington.
