HISTORIC RESOURCES INVENTORY:
Buildings & Structures

SURVEY OF GUILFORD, NEW HAVEN COUNTY, 06437
June-December 1981

1. ADDRESS 2545 Long Hill Road
(map 105, lot 1)
2. NAME
(historic) Stephen Fowler
NAME
(common)
3. USE
(historic)
USE
(present) Private house
4. IF MOVED, WHEN AND FROM WHERE:

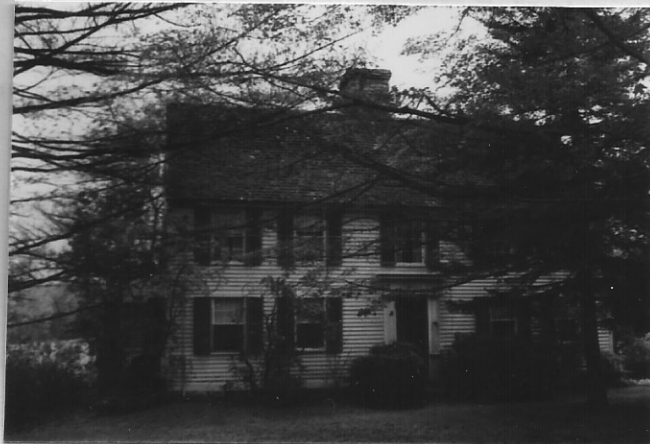
5. ARCHITECT
6. DATE 1770 BUILDER STYLE Colonial - Lean-to
7. ALTERATIONS
Shed roof addition; Greek Revival doorway with pilasters and entablature; 6/6 sash.
8. NOTABLE FEATURES
Boxed cornice; 6/6 pane gable window (see in the second floor lean-to portion); stone chimney; stone foundation.

9. ARCHITECTURAL-HISTORICAL A wood-shingled roof, large stone chimney, and long sloping rear roof covering a lean-to integral to the house are features common to Guilford's houses of the 18th century. To find them with few changes, as in this house, is unusual.
The Stephen Fowler house, known in the 20th century as the Harold E. Fowler place, contained the first post office in North Guilford. Harold Fowler's grandfather, Stephen, was the postmaster for many years prior to his death in 1869. Harold's aunt continued the office into the 1870s until she married and moved away. Mail was brought by stage coach from New Haven via Foxon and North Branford arriving in North Guilford at noon. The horses were fed under a cherry tree which stood in the front of the house while the men ate lunch before proceeding to Deep River. The mail coach ran twice a week.
