**HISTORIC RESOURCES INVENTORY:**  
Buildings & Structures

**SURVEY OF GUILFORD, NEW HAVEN COUNTY, 06437**  
June-December 1981

1. ADDRESS 2655 Long Hill Road  
(map 104, lot 13)
2. NAME Benaijah Stone  
(historic)  
NAME  
(common)
3. USE  
(historic)  
USE  
(present) Private house
4. IF MOVED, WHEN AND FROM WHERE:

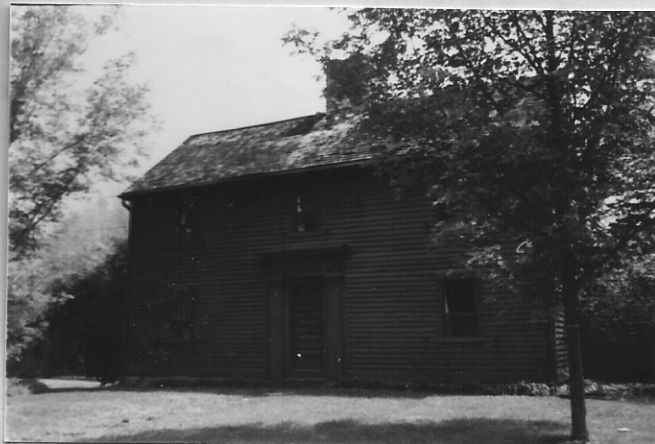
5. ARCHITECT
6. DATE 1730 BUILDER STYLE Colonial
7. ALTERATIONS Side addition and garage attached; gable windows; Greek Revival doorway with an entablature and pilasters.
8. NOTABLE FEATURES Overhanging eaves; 12/8 sash (first floor); 6/6 sash (second floor); stone chimney; stone block foundation (no mortar used).

9. ARCHITECTURAL-HISTORICAL A fine stone chimney crowns the uneven wood-shingled roof of this house. The center of this house also gains importance from the massive plain Greek Revival doorway. An excellent example of the one room plus lean-to form of Colonial house with a five-window facade, this house is one of the oldest in North Guilford.  
According to a citation in the Dana Collection, Joseph Chittenden was the original owner of this house. Presumably he was the great-grandson of William, one of the covenanters. A cooper by trade, he was born in 1702; died in 1794.  
It was owned by Benaijah Stone who sold it on 3 March 1746 for 410 pounds to Samuel Fyler. Stone moved to Fairfield County. The house had eleven owners before it was bought in 1802 by Reuben Johnson son of Isaac of North Guilford. Following (cont'd. on next sheet)
