HISTORIC RESOURCES INVENTORY:
Buildings & Structures

SURVEY OF GUILFORD, NEW HAVEN COUNTY, 06437
June-December 1981

1. ADDRESS 2814 Long Hill Road
(map 104, lot 18)
2. NAME
(historic) Medad Holcomb
NAME
(common)
3. USE
(historic)
USE
(present) Private house
4. IF MOVED, WHEN AND FROM WHERE:

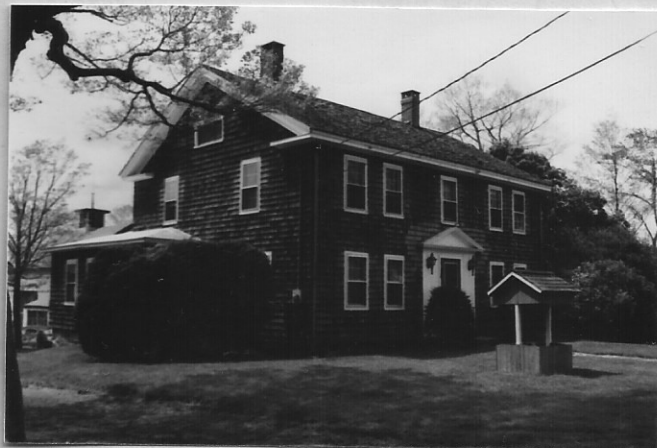
5. ARCHITECT 1805
6. DATE 1805
- BUILDER
STYLE Federal
7. ALTERATIONS
Modern door; shingle siding; chimneys; side addition; 6/6 sash.

8. NOTABLE FEATURES
Boxed cornice with returns; rectangular gable window (maybe c1840); stone and brick foundation.
9. ARCHITECTURAL-HISTORICAL
This is a well proportioned house of the early 19th century that has acquired new features like small chimneys and shingle siding as it was adapted to the changing needs of the practical farmers who lived there. Some of its cluster of barns are said to date back to the 18th century; others were moved here shortly after the Civil War. Although it is no longer operating as a dairy farm, it is a virtually complete milk-producing farm complex, a very rare survival from Guilford's agricultural past.
The Rev. William Vaill and his wife bought this house, for their use while he was pastor of the North Guilford Congregational Church in 1809.
See also Medad Holcomb house, 95 Fair Street.
