HISTORIC RESOURCES INVENTORY:
Buildings & Structures

SURVEY OF GUILFORD, NEW HAVEN COUNTY, 06437
June-December 1981

1. ADDRESS 361 Long Hill Road
(map 79, lot 10)
2. NAME Timothy Cruttenden
(historic)
NAME
(common)
3. USE
(historic)
USE Private house
(present)
4. IF MOVED, WHEN AND FROM WHERE:

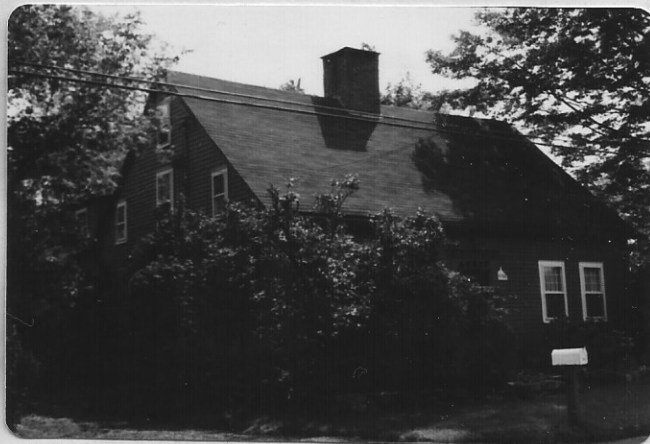
GLFD NEG 4:28

5. ARCHITECT
6. DATE 1778
- BUILDER STYLE Colonial
7. ALTERATIONS
Addition (1950s); dormer in the rear ell.

8. NOTABLE FEATURES
Overhanging eaves with a moulding below; 12/12 sash; 6/6 in the garret and the second floor roof eaves; very thin mouldings above the window frames; thin window sills; doorway with a five pane transom; plain door frame, and a crown moulding above the transom.
9. ARCHITECTURAL-HISTORICAL
This house has a facade with two windows on each side of a central doorway and gable ends with a large center window and smaller ones on either side and in the garret. There are typical features of Guilford many story-and-a-half Colonial houses. Here the facade is highlighted by a door surmounted with mouldings and a transom in the frame. The house is a very fine example of its form and style.

| <input type="checkbox"/> Excellent | <input checked="" type="checkbox"/> Good | <input type="checkbox"/> Fair | <input type="checkbox"/> Poor | <input type="checkbox"/> Bad |
