HISTORIC RESOURCES INVENTORY - BUILDING AND STRUCTURES

Building Name (Common) 749 Long Hill Road
 Building Name (Historic) Nathan Benton House
 Street Address or Location 749 Long Hill Road
 Town/City Guilford Village _____ County New Haven
 Owner(s) Pribo Properties, LLC Public Private

Style of building Colonial Date of Construction c. 1794 (Helander)

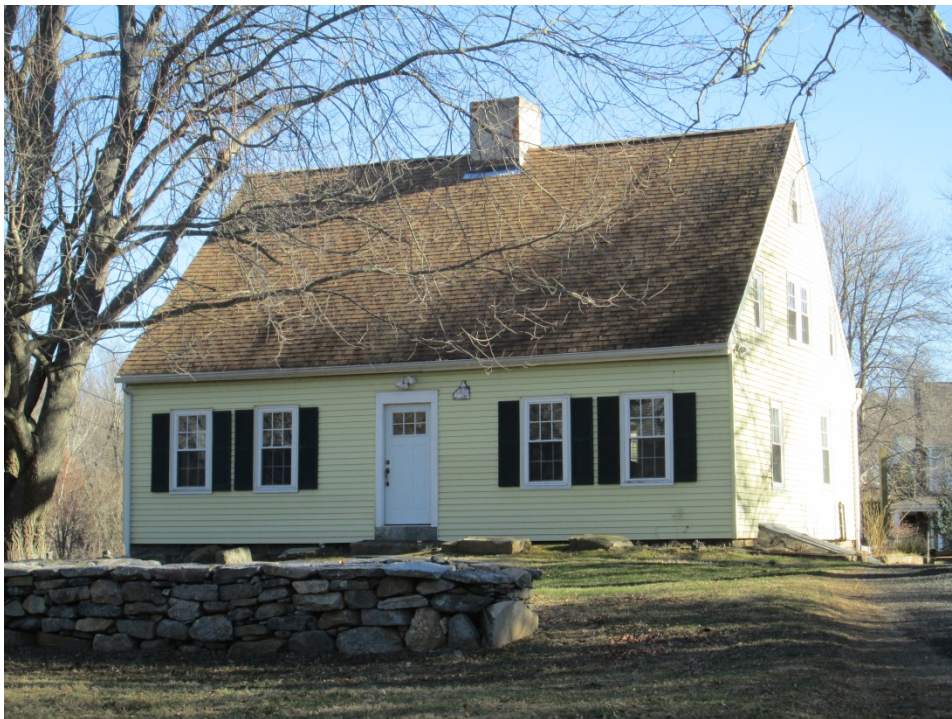
This is a two-story Colonial dwelling with an attic and a side-gable roof. The roof is covered in asphalt shingles, and the house is sheathed in aluminum siding. The five bay façade faces west, and the main entry is centered on this side. Fenestration consists of six-over-six double-hung windows. A large masonry chimney is centered on the ridgeline. (See continuation sheet)

Photographer Kristen Nietering Date 1/21/2015
View West view of the house, camera facing east Negative on File _____
Name Kristen Nietering Date 10/26/2015
Organization Guilford Preservation Alliance
Address 199 PO Box Guilford, CT 06437

Colonial features include the steeply-pitched roof, low eaves, and symmetrical façade design. Additions and a garage extend off the east (rear) elevation.
