**HISTORIC RESOURCES INVENTORY:**  
 Buildings & Structures

**SURVEY OF GUILFORD, NEW HAVEN COUNTY, 06437**  
 June-December 1981

1. ADDRESS 108 Lovers Lane  
 (map 41, lot 32)

2. NAME Joseph Weld  
 (historic)  
 NAME  
 (common)

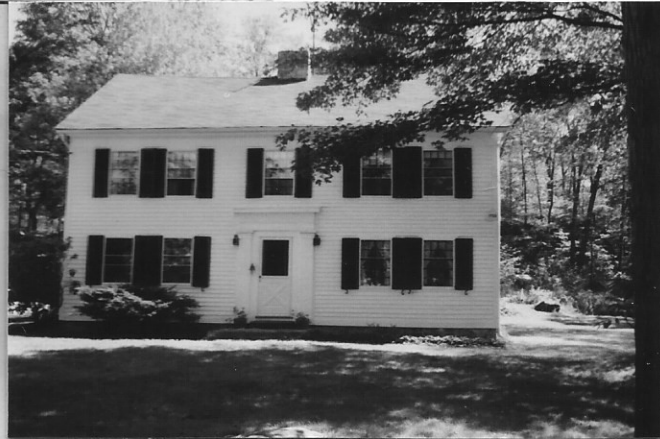
7. ALTERATIONS  
 Rear lean-to addition; chimney; Greek Revival doorway with  
 pilasters and a large entablature; screen door.

8. NOTABLE FEATURES  
 Frieze; 8/12 sash; stone foundation.

Moved here from Whitfield Street, on the south side of the Green,  
 this house now has a deep front yard that gives it a rural appearance.  
 Its regular facade with two rows of windows of the same size make it  
 a good example of the mid 18th-century houses of Guilford's center  
 district.
