HISTORIC RESOURCES INVENTORY:
 Buildings & Structures

SURVEY OF GUILFORD, NEW HAVEN COUNTY, 06437
 June-December 1981

1. ADDRESS 1285 Moose Hill Road
(map 72, lot 8)
2. NAME Benjamin Fowler
(historic)
NAME
(common)
3. USE
(historic)
USE
(present) Private house
4. IF MOVED, WHEN AND FROM WHERE:

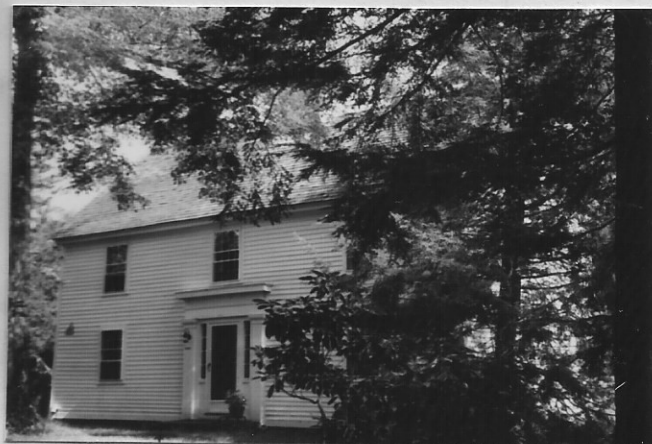
5. ARCHITECT
6. DATE 1752
- BUILDER
STYLE Colonial
7. ALTERATIONS
Rear addition (attached by a hall); Greek Revival doorway with pilasters, entablature, and sidelights.
8. NOTABLE FEATURES
8/12 sash; 6/6 sash in the gable; large stone chimney; stone foundation.

9. ARCHITECTURAL-HISTORICAL The wide spacing of the five windows of the facade are a noteworthy feature of this Colonial house, an excellent example of the mid 18th century with few changes since. A Greek Revival doorway is an addition common to many of Guilford's Colonial houses. This doorway is especially large, with sidelights as well as the usual pilasters and entablature. A secluded setting with a pond make important contributions of the site of this house.
Benjamin Fowler, probably the same man who later owned this house, was a grand juror of the Town, January 1729. A sergeant by this name and a Benjamin Fowler, Jr. fought in the French and Indian Wars.
