HISTORIC RESOURCES INVENTORY:
Buildings & Structures

SURVEY OF GUILFORD, NEW HAVEN COUNTY, 06437
June-December 1981

1. ADDRESS 91 North Madison Road
(map 92, lot 25)
2. NAME
(historic) Daniel Loper
NAME
(common) Maplehurst Farm
3. USE
(historic)
USE
(present) Private house
4. IF MOVED, WHEN AND FROM WHERE:

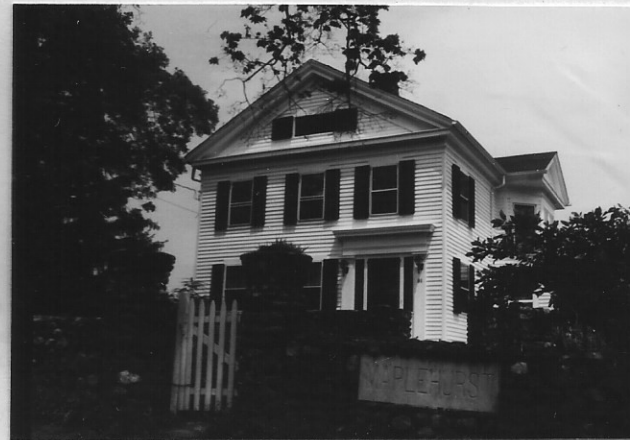
5. ARCHITECT
6. DATE 1839
- BUILDER William Weld
- STYLE Greek Revival
7. ALTERATIONS
Cross gable projection (with beveled sides); 6/2 sash; rear addition.

8. NOTABLE FEATURES
Wide lintel boards over the window; doorway with pilaster; an entablature (with dentils under the cornice); and sidelights (with decorative muntins).

9. ARCHITECTURAL-HISTORICAL The hilltop setting of this house, overlooking the head of the East River at the Guilford Lakes, inspired successive owners to enlarge and embellish it. Originally this was a Greek Revival house with an impressive entryway; a bevel-sided projection opened the house for a better view across the valley later in the 19th century. A wall of rounded stones, probably constructed in the early years of this century, adds a rural quality; next to the gate the name "Maplehurst" carved in stone shows the owner's pride in this house and attractive site.
William Weld built the house for Daniel Loper from December 1838 until its completion in September 1839. Loper bought the land from Christopher B. Davis. Loper's grandson, Daniel Loper Davis, inherited the property in 1843. He sold it, in 1872, to Charles S. Parker.
