HISTORIC RESOURCES INVENTORY:
 Buildings & Structures

SURVEY OF GUILFORD, NEW HAVEN COUNTY, 06437
 June-December 1981

1. ADDRESS 394 Norton Town Road
(map 88, lot 4A)
2. NAME
(historic)
NAME
(common)
3. USE
(historic)
USE
(present) Private house
4. IF MOVED, WHEN AND FROM WHERE:

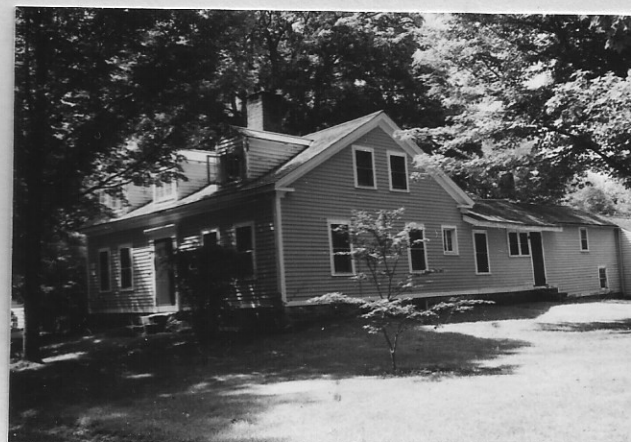
5. ARCHITECT
6. DATE See Below
7. ALTERATIONS
Rear additions; dormer windows.

BUILDER
STYLE Federal/Greek Revival

8. NOTABLE FEATURES
Narrow frieze; 6/6 sash; doorway with slender pilasters and an entablature; stone foundation and chimney.
9. ARCHITECTURAL-HISTORICAL
 This fine five-bay story-and-a-half house has features which place it in the Federal, or possibly early Greek Revival, Period. A plaque on the house gives the name of Crampton and a date of 1757. The pitch of the roof, the cornices with small returns, and the narrow frieze make it difficult to date as early as 1757. The house would appear to date from the first quarter of the 19th century or slightly thereafter. Further investigation might reveal an earlier structure on the site. This house is located in a wooded area at the eastern side of the township near the present Madison town line.
 The house appears on the 1852 Map with the name Daniel Foster.
