HISTORIC RESOURCES INVENTORY:
 Buildings & Structures

SURVEY OF GUILFORD, NEW HAVEN COUNTY, 06437
 June-December 1981

1. ADDRESS 60 Nortontown Road
 (map 82, lot 6)
2. NAME
 (historic)
 NAME
 (common)
3. USE
 (historic)
 USE
 (present) Private house
4. IF MOVED, WHEN AND FROM WHERE:

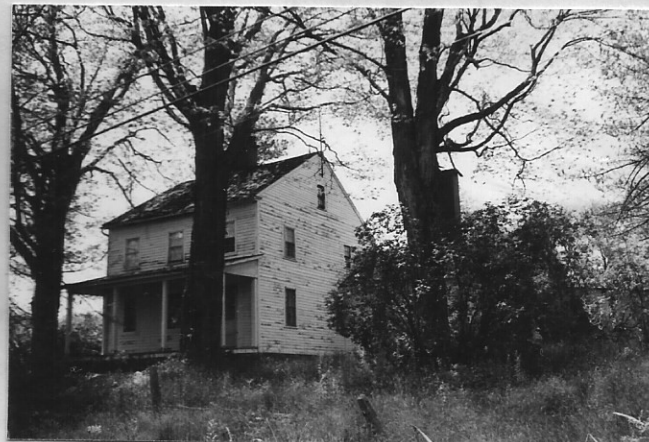
8. NOTABLE FEATURES
 Overhanging eaves with a moulding below; central brick chimney; 6/6 sash; doorway with slender pilasters and a stylized entablature; front porch with square post (later addition?); stone foundation.

9. ARCHITECTURAL-HISTORICAL
 Practically devoid of ornament, the simplicity of this small house becomes its dominant feature. Later additions are set well back. The narrow three-bay width is most unusual for a two-story central chimney house. Set in remote marginal farm and woodland, it is a well-proportioned and interesting rural house.
 The name of Eber S. Hotchkiss is assigned to this property on the 1852 Map. Eber Hotchkiss, a shipwright, built his first vessel, a sloop, in the woods on his farm located "about three miles north of the East River Bridge" circa 1835. He then established a yard south of the Bridge where he built and launched a total of 32 vessels, according to his grandson, Charles O. Hotchkiss of Deep River.
