HISTORIC RESOURCES INVENTORY:
 Buildings & Structures

SURVEY OF GUILFORD, NEW HAVEN COUNTY, 06437
 June-December 1981

1. ADDRESS 729 Nut Plains Road
 (map 86, lot 30)
2. NAME
 (historic) Thomas Griswold V
 NAME
 (common)
3. USE
 (historic)
 USE
 (present) Private house
4. IF MOVED, WHEN AND FROM WHERE:

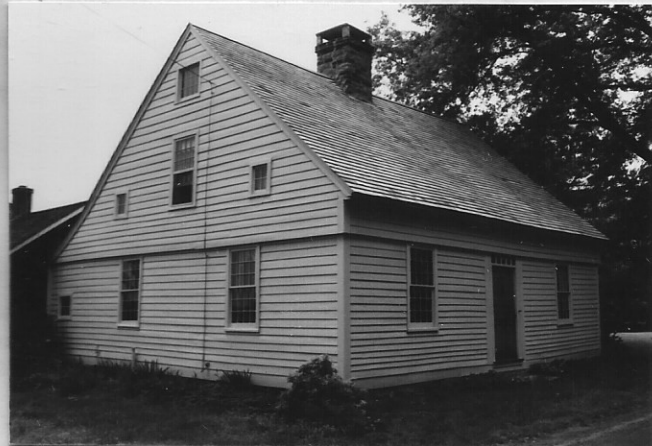
8. NOTABLE FEATURES
 Overhanging eaves; 12/12 sash; twelve pane garret window; four pane windows in the second floor roof portion; stone chimney and foundation.

9. ARCHITECTURAL-HISTORICAL A small overhang along the front and sides of this house just above the door and first-floor windows unifies this structure horizontally and yet expresses the vertical division of its interior on the exterior. The windows of this house, which may have been replaced, are of the size, configuration, and placement that typifies Guilford's one-and-a-half-story Colonial houses, of which this is a splendid example.
 Thomas Griswold V broke ground for the cellar of this house 15 April 1791 and moved in 31 December 1791, according to his diary. The house was owned by William and Walter Griswold in 1852.
 Thomas Griswold may have been identical with the Private who served in Capt. Hand's Company, Col. Talcott's Regiment in 1776.
