HISTORIC RESOURCES INVENTORY:
 Buildings & Structures

SURVEY OF GUILFORD, NEW HAVEN COUNTY, 06437
 June-December 1981

1. ADDRESS 54 Old Quarry Road
 (map 12, lot 14)
2. NAME
 (historic)
 NAME
 (common)
3. USE
 (historic)
 USE
 (present) Private house
4. IF MOVED, WHEN AND FROM WHERE:

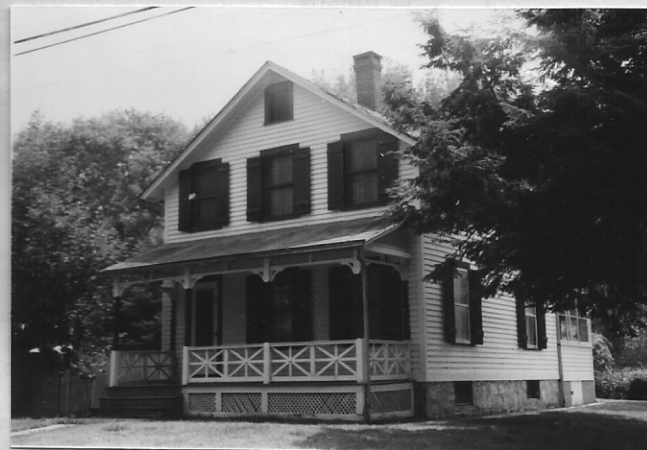
5. ARCHITECT
6. DATE c1900
7. ALTERATIONS
 Rear shed roof addition.
8. NOTABLE FEATURES
 Overhanging eaves with visible rafters; porch with decorative posts, brackets and a decorative railing; stone foundation.

9. ARCHITECTURAL-HISTORICAL
 The most outstanding feature on this two-story, three-bay house is the front porch. A simple, open frieze is formed under the cornice with the use of periodically spaced straight pieces of wood. A "star" pattern forms the porch railing between square, bracketed posts.
