HISTORIC RESOURCES INVENTORY:
Buildings & Structures

SURVEY OF GUILFORD, NEW HAVEN COUNTY, 06437
June-December 1981

1. ADDRESS 316 (Old) Whitfield Street
(map 33, lot 22)
2. NAME
(historic) Railroad Water Tower and
NAME Repair Building
(common)
3. USE
(historic) Railroad Water Tower and
USE Repair Building
(present)
4. IF MOVED, WHEN AND FROM WHERE:

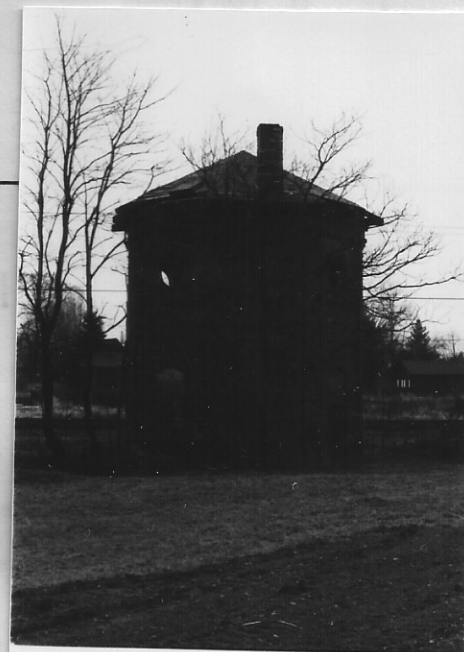
8. NOTABLE FEATURES
Repair building - overhanging eaves; round windows in the gable; plain brick pilasters separating the arched windows. Water tower - octagon shape; brick pilasters; segmental arched windows (1st level) and circular windows on the second level; corbeling below the over-
9. ARCHITECTURAL-HISTORICAL hanging eaves and the frieze.

Arched openings in the east end of this solid brick-pier building c1875 let locomotives in and out of this repair facility; large windows illuminated the work. Nearby an octagonal brick water-tower of approximately the same date is highlighted by the brick frieze and corner pilasters. The wooden framework which supported the water tank remains intact inside the tower. Water in the tower could be heated to prevent freezing and provide preheated water for the locomotive boilers. These buildings are rare survivals of the many small service facilities of the steam-powered railroad.
