**HISTORIC RESOURCES INVENTORY:**  
Buildings & Structures

**SURVEY OF GUILFORD, NEW HAVEN COUNTY, 06437**  
June-December 1981

1. ADDRESS 192 Opening Hill Road  
(map 82, lot 25)
2. NAME  
(historic) D. Norton and R. Hall  
NAME  
(common)
3. USE  
(historic)  
USE Private house  
(present)
4. IF MOVED, WHEN AND FROM WHERE:

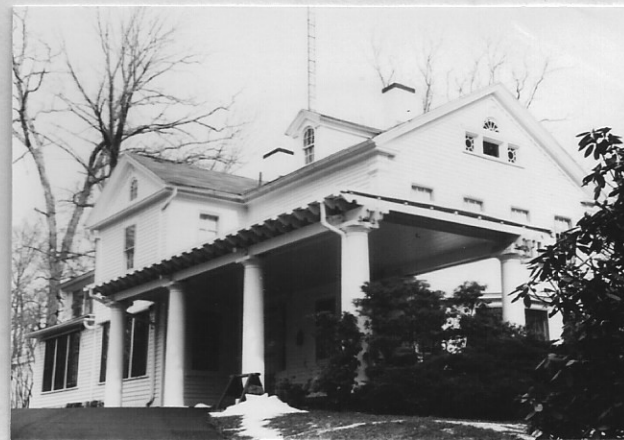
5. ARCHITECT
6. DATE cl850 alterations cl920
7. ALTERATIONS Large porches (cl920) with round columns and decorative rafters; rear addition; bay window.
8. NOTABLE FEATURES Boxed cornice (pedimented on the side gables and with returns on the front); recessed panel pilasters on the corners of the house; dormers (with pilasters); Palladian-like window with decorative wood muntins; doorway with colonnettes, fret design, sidelights and transom with leaded muntins; brick chimney, stone foundation.

9. ARCHITECTURAL-HISTORICAL  
This house, of Greek Revival style much modified since building, has a broad wing with more elaborate detailing than the narrower section crossing it. Gable windows in both wings and dormers appear to be Colonial Revival additions of about 1920. A grand porch of the same era opens the house to its grounds. Set on a carefully landscaped hill in an exquisite natural setting with pond and streams, this house is a wonderful surprise in a remote wooded section of Guilford.  
The house originally was in the town of Madison, however changes in the town line have placed the house in Guilford while some of the land still remains in Madison.
