**HISTORIC RESOURCES INVENTORY:**  
Buildings & Structures

**SURVEY OF GUILFORD, NEW HAVEN COUNTY, 06437**  
June-December 1981

1. ADDRESS 67 Park Street  
(map 40, lot 2)
2. NAME  
(historic)  
NAME  
(common) Guilford Free Library
3. USE  
(historic) Library  
USE  
(present) Library
4. IF MOVED, WHEN AND FROM WHERE:

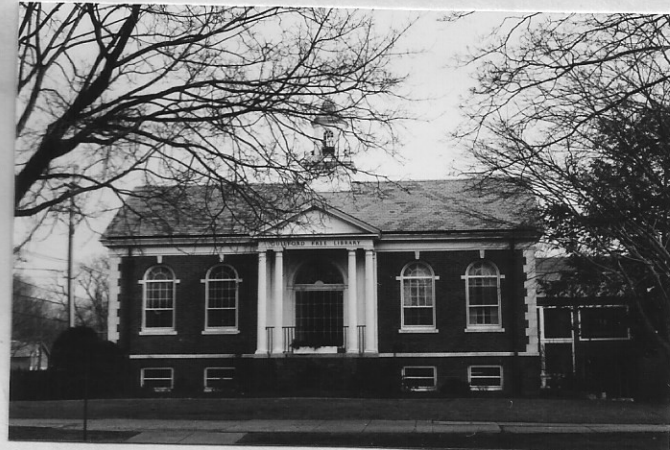
Date FALL 1981 Negative 23:8A

5. ARCHITECT <sup>Archer</sup> G. Arthur Quick
6. DATE 1933
- BUILDER  
STYLE Colonial Revival
7. ALTERATIONS  
Addition to rear; front entry changed to window, steps removed.

8. NOTABLE FEATURES  
Dentils below the eaves; frieze; central "portico" with fluted columns and pilasters; stone belt course above the basement windows; stone quoins, keystones and springstones (on arched windows); cupola with a square base and an octagonal top with arched windows.

9. ARCHITECTURAL-HISTORICAL  
The gable and columns of the central portico, arched windows, and cupola give the Library the stately but accessible presence of the Federal Revival of the 1930s. Stone, wood and brick work well together to produce a building whose scale and ornament enhance those of its neighbors around the Green.  
The Guilford Free Library was built in 1933 on land donated by Frederick C. Spencer, who had bought the property and cleared the lot in 1915. Miss Clara I. Sage had left a bequest designated for this purpose. A New Haven architect, G. <sup>Archer</sup> Arthur Quick, who also designed the Adams School, drew up the plans which were accepted in May of 1933.  
As the Town's population grew in the 1960-70s, (cont'd next sheet)
