HISTORIC RESOURCES INVENTORY - BUILDING AND STRUCTURES

GENERAL INFORM	-				
Building Name (Comm	on) 18 Pearl Stre	et			
Building Name (Histori	_{c)} <u>W. Elliott Bark</u>	er House			
Street Address or Locat	ion 18 Pearl Stre	et			
Town/City Guilford		Village	(County New Haven	
Owner(s) Roberta M.	Griffiths			Public	X Private
PROPERTY INFOR	MATION				
Present Use:	e: Single Family	Dwelling			
Historic Use: Residence					
Accessibility to public			Yes 🗌 No		
Interior accessible?	Yes X No	If yes, explain			
Style of building Crafts				f Construction 1928 (He	lander)
Material(s) (Indicate use					
Clapboard	Asbestos Sidin	g 🗌 Brick	Wood Shin	gle 🗌 Asphalt S	iding
Fieldstone	Board & Batter	n 🗌 Stucco	Cobblestor	ne 🗌 Aluminur	n Siding
Concrete (Typ	e	_) 🗌 Cut Sto	пе (Туре) X Other Vir	nyl
Structural System					
🗙 Wood Frame	🗌 Post & Beam	Balloon	Load bearing	masonry Structur	ral iron or steel
Other					
Roof (<i>Type</i>)					
🗙 Gable	🗙 Flat	☐ Mansard	Monitor	Sawtooth

18 Pearl Street

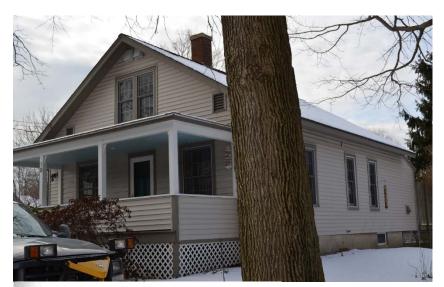
Built in 1928, this one and a half story Craftsman style building sits atop a poured concrete foundation and is sheathed in beige vinyl clapboards. The front gable roof is covered in architectural shingles and has two chimneys along the ridgeline. A pair of six over six hung sash windows is located near the roof peak. Two louvered vents are on either side of the top half level. (See Continuation Sheet)

Two eight over eight hung sash windows are on the first floor level with a door in the middle. A full façade porch with a flat roof covers the windows and front door entry. White square columns are attached to a cornice just under the roof. Instead of a balustrade is a vinyl sided kneewall that wraps around the porch.

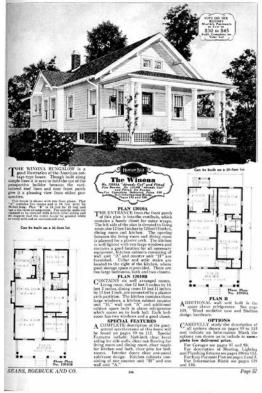
Sears Home 1927-1932, Sears Archives Online

The first owner of this house was W. Elliott Barker and his wife Teresa in 1928. Barker was a house carpenter and the date of "1928" allegedly appears in the chimney according to a past owner. Later owners were James Schlegel and then Edwards Brashears around 1980. Brashears had reason to believe that this house may have been a pre-fab house, possibly Sears-Roebuck. Upon a quick search of the Sears archives, this home is indeed very similar to the "Winona" model of home in the catalog (see Continuation Sheet for photo).
