HISTORIC RESOURCES INVENTORY:
 Buildings & Structures

SURVEY OF GUILFORD, NEW HAVEN COUNTY, 06437
 June-December 1981

1. ADDRESS 52 Pearl Street
 (map 40, lot 51)
2. NAME
 (historic) John C. Norton
 NAME
 (common)
3. USE
 (historic)
 USE Private house
 (present)
4. IF MOVED, WHEN AND FROM WHERE:

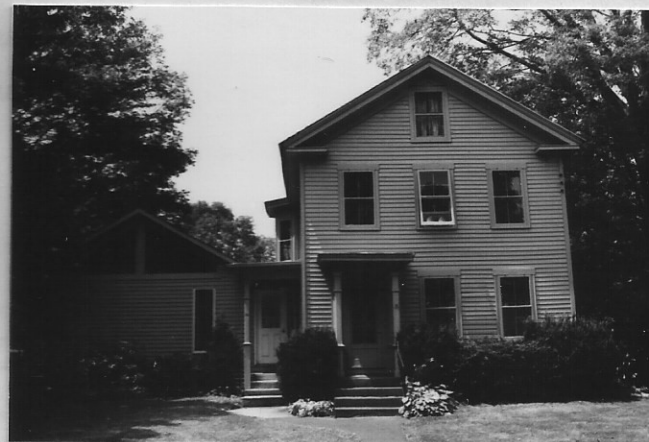
5. ARCHITECT
6. DATE 1879
7. ALTERATIONS
 Modern addition on south side; gable window enlarged; railing on front steps.
8. NOTABLE FEATURES
 Boxed cornice with returns; freize; 2/2 sash; two story bay window on side; entry with beveled edged square posts supporting a flat roof top; granite block foundation.

BUILDER John C. Norton
 STYLE Greek Revival/Italianate
