HISTORIC RESOURCES INVENTORY:
 Buildings & Structures

SURVEY OF GUILFORD, NEW HAVEN COUNTY, 06437
 June-December 1981

1. ADDRESS 741 Podunk Road
(map 93, lot 6)
2. NAME
 (historic) Joseph Bartlett
 NAME
 (common)
3. USE
 (historic)
 USE
 (present) Private house
4. IF MOVED, WHEN AND FROM WHERE:

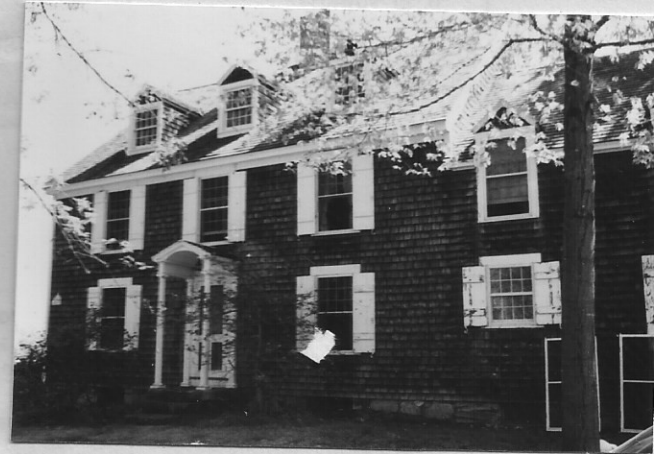
5. ARCHITECT
6. DATE 1752
- BUILDER
 STYLE Colonial and Colonial Revival
7. ALTERATIONS
 Side addition; shingle siding; dormers; side fenestration altered; rebuilt brick chimney; Federal doorway with slender columns, and a pediment door hood with dentils.
8. NOTABLE FEATURES
 Boxed cornice; frieze; 12/12 sash; 8/12 sash in the gable, stone foundation.

9. ARCHITECTURAL-HISTORICAL
 The original three-bay house of Joseph Bartlett was enlarged in the Colonial Revival mode of the 1920s and 30s with dormers in the attic, a story-and-a-half dormered extension, and a garage with arched doorways. The shingle siding, probably added at the same time, helps unify the various parts of the house. The slender columned entryway and the shutters are further Colonial Revival touches. This is a good illustration of successful blending of 18th and 20th century "Colonial" styles.
