**HISTORIC RESOURCES INVENTORY:**  
 Buildings & Structures

**SURVEY OF GUILFORD, NEW HAVEN COUNTY, 06437**  
 June-December 1981

1. ADDRESS 59 Prospect Avenue  
(map 2, lot 49-2)
2. NAME Charles A. Way  
(historic)  
NAME  
(common)
3. USE  
(historic)  
USE Private house  
(present)
4. IF MOVED, WHEN AND FROM WHERE:  
1903 from 92 Prospect Avenue

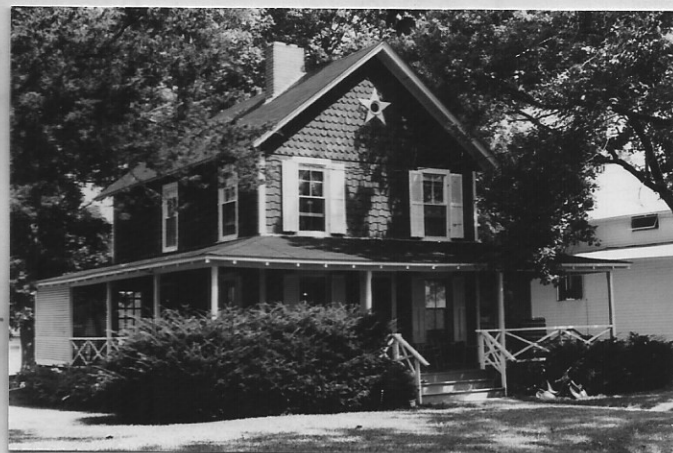
5. ARCHITECT
6. DATE 1886
- BUILDER  
STYLE Queen Anne
7. ALTERATIONS  
Screened portion of the front porch.

8. NOTABLE FEATURES  
Overhanging eaves with visible rafter ends; fishscale shingles in the gable; alternating lengths of shingles on the first and second floors; round gable window with star design around the frame; wrap around porch.

The broad porch surrounding this cottage opens it to the sea breezes while sheltering its inhabitants from the hot summer sun. The star in the gable is a novel complement to the interesting textures of the house's shingling. The house is typical of the summer cottages built before the turn of the century in the New Haven area. (See also 67 Chimney Corners and 110 Prospect).
