**HISTORIC RESOURCES INVENTORY:**  
 Buildings & Structures

**SURVEY OF GUILFORD, NEW HAVEN COUNTY, 06437**  
 June-December 1981

1. ADDRESS 92 Prospect Avenue  
(map 1, lot 12)
2. NAME  
(historic) "Villa Louise"  
NAME  
(common)
3. USE  
(historic)  
USE  
(present) Private house
4. IF MOVED, WHEN AND FROM WHERE:

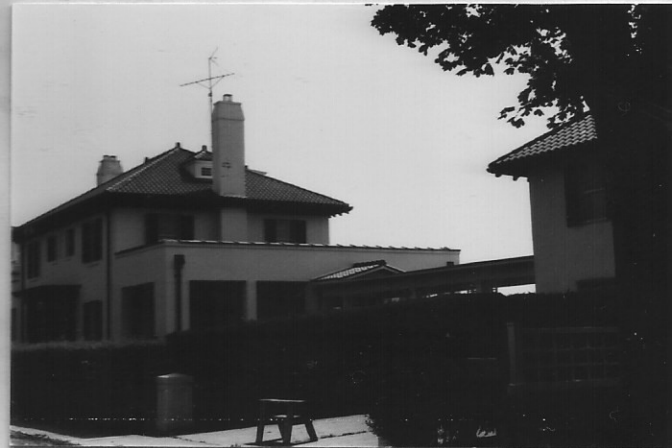
BUILDER Clark Company, New Haven  
 STYLE Spanish Colonial Revival

8. NOTABLE FEATURES The two portions of the house connected by a tunnel; overhanging eaves with decorative rafters; tile roof; hip roof dormer windows on the side; square post porch with decorative lattice work; a mediterranean style iron "grill" in front of the front door of the main house.
