HISTORIC RESOURCES INVENTORY:
 Buildings & Structures

SURVEY OF GUILFORD, NEW HAVEN COUNTY, 06437
 June-December 1981

1. ADDRESS 222 Race Hill Road
 (map 109, lot 35A)
2. NAME
 (historic) George Bartlett II
 NAME
 (common) Bartlett Tavern
3. USE
 (historic) Residential/Tavern
 USE
 (present) Private house
4. IF MOVED, WHEN AND FROM WHERE:
 from Durham Turnpike to Race Hill
 Road in 1951

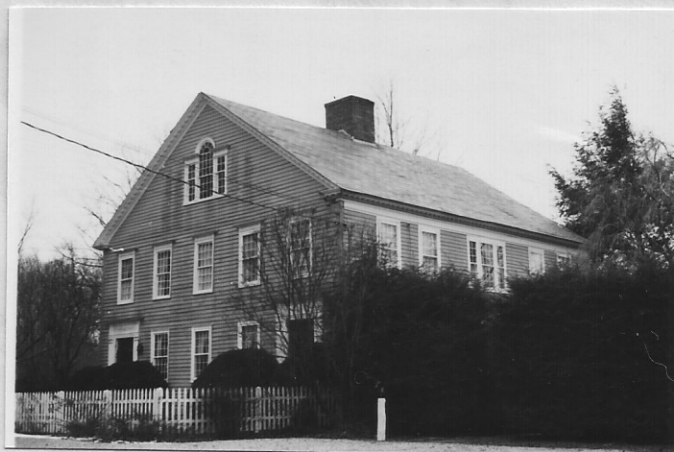
8. NOTABLE FEATURES
 Return cornice with Federal trim (mutules, gouge work, and mock
 dentils); window with 12/12 sash; Federal trim on front and side
 doorways; Palladian windows; cut stone block foundation.

9. ARCHITECTURAL-HISTORICAL
 Exceptionally fine Federal detailing graces this large tavern, turning
 this 18th century house into an accomodation for travelers. In add-
 ition to fancy trim along the eaves, Palladian windows with fluted
 pilasters punctuate the gables, and a simpler version of the Palladian
 window spreads over the front door. The side doors, at either corner
 of the end, are embellished with fluted pilasters and an ornamented
 pediment. Old small-paned sash windows are an important part of the
 appearance of this building. Second-floor windows in the ends are
 finished with a crown molding, those on the front and back with a
 frieze extending to the eave trim. This is a large building--five
 bays wide and five bays long--dimensions appropriate for an inn.
 Its large size, wealth of detail, and history make this an important
 and unusual building. (cont'd on next sheet)
