HISTORIC RESOURCES INVENTORY:
Buildings & Structures

SURVEY OF GUILFORD, NEW HAVEN COUNTY, 06437
June-December 1981

1. ADDRESS 110 State Street
(map 46, lot 7)
2. NAME
(historic) Thomas Scranton
NAME
(common)
3. USE
(historic)
USE
(present) Private house and
dentist's office
4. IF MOVED, WHEN AND FROM WHERE:

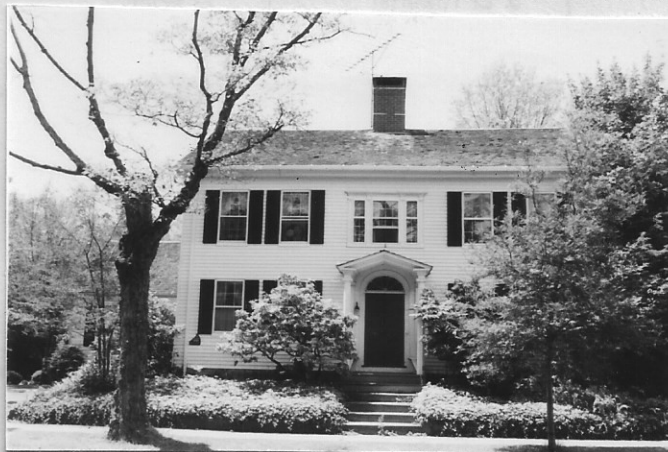
5. ARCHITECT
6. DATE c1810
- BUILDER
STYLE Federal
7. ALTERATIONS
Chimney rebuilt; additions on side; aluminum/vinyl siding; aluminum sash.
8. NOTABLE FEATURES
Triple window, carved trim, and one of Guilford's prettiest doorways, led up to by a gradual flight of steps and framed by nice planting.

9. ARCHITECTURAL-HISTORICAL
A delicate pediment supported by slim columns shelters a semicircular fanlight decorated by swags in the entrance to the Thomas Scranton house, an excellent example of Federal design in Guilford. On the second floor, a very handsome three-part window has panelling and brackets that suggest the pilasters and capitals of the original Palladian style. This house and the Samuel Scranton, [redacted] house of the same period across the street (107 State) make a strong statement at this important corner. Weathered barns remain out back.
