**HISTORIC RESOURCES INVENTORY:**  
Buildings & Structures

**SURVEY OF GUILFORD, NEW HAVEN COUNTY, 06437**  
June-December 1981

1. ADDRESS 1 State Street  
(map 40, lot 96)
2. NAME  
(historic) Samuel Eliot (also called  
NAME Leonard Chamberlain house)  
(common)
3. USE  
(historic)  
USE  
(present) Two-family house
4. IF MOVED, WHEN AND FROM WHERE:

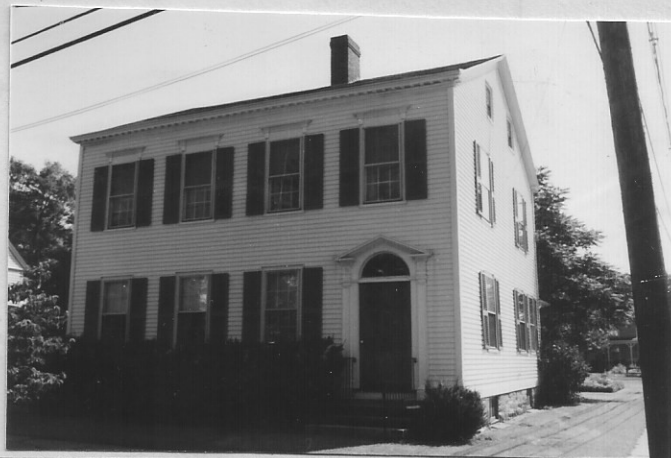
5. ARCHITECT
6. DATE 1803
- BUILDER  
STYLE Federal
7. ALTERATIONS
8. NOTABLE FEATURES Rear ell and chimney appear to be later additions. Although the walls are now covered with aluminum (or vinyl) siding, care has been taken not to injure or hide any of the trim, which is this house's particular distinction. Siding is never a satisfactory substitute for the real thing, but this house is a heartening reminder that it doesn't have to be disfiguring.

9. ARCHITECTURAL-HISTORICAL  
Stylish houses often tend to be near the center of town, and the Samuel Eliot house has some very fine Federal details in its cornice trim, second story window caps, and doorway. The entry is a noteworthy feature; its pilasters with carved rosettes support a triangular pediment that shelters a semicircular fanlight. This is a fitting beginning to an attractive street.
