HISTORIC RESOURCES INVENTORY:
Buildings & Structures

SURVEY OF GUILFORD, NEW HAVEN COUNTY, 06437
June-December 1981

1. ADDRESS 264 State Street
(map 53, lot 9)
2. NAME
(historic) Joel & Lucy Griswold
NAME
(common)
3. USE
(historic)
USE
(present) Private house
4. IF MOVED, WHEN AND FROM WHERE:

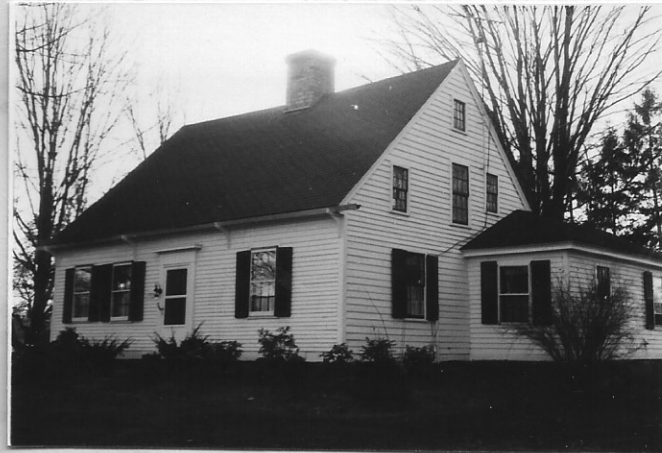
5. ARCHITECT
6. DATE 1793
- BUILDER
STYLE Late Colonial
7. ALTERATIONS
North side addition; 6/6 windows; brackets supporting wood gutter; asphalt shingles on roof.
8. NOTABLE FEATURES

9. ARCHITECTURAL-HISTORICAL
The Joel and Lucy Griswold house has an unusual asymmetrical facade with two windows on one side of the door and one on the other: possibly the pair is a later addition, as is the Greek Revival doorway. The leanto is of the integral type, as would be expected at this date, and the chimney at the ridge of the long steep roof is of very neatly laid and carefully cut stone. This is an interesting treasure in Guilford's trove of one-and-a-half-story houses of the late 18th century.
