HISTORIC RESOURCES INVENTORY:
 Buildings & Structures

SURVEY OF GUILFORD, NEW HAVEN COUNTY, 06437
 June-December 1981

1. **ADDRESS** 152 and 164 Tanner Marsh Road
 (map 77, lot 44) and (map 75, lot 44A)
2. **NAME** Horace 'Francis' Dudley
 (historic)
NAME Hillcrest Farm
 (common)
3. **USE** 152 - Milk Processing Plant
 (historic) 164 - Private house
USE 152 - Private house
 (present) 164 - Private house
4. **IF MOVED, WHEN AND FROM WHERE:**

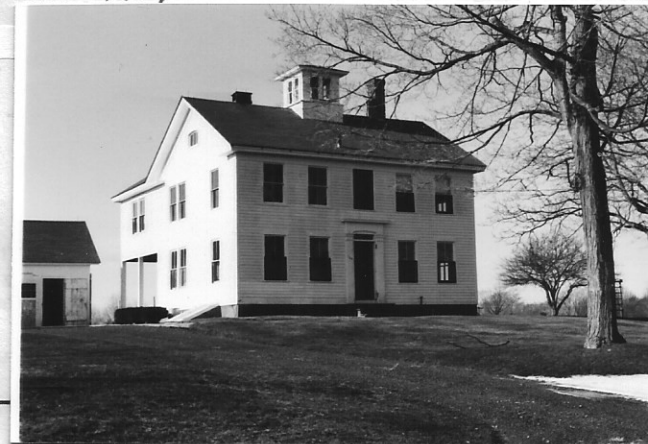
8. **NOTABLE FEATURES** 164 - Cupola; slightly arched gable window; wide lintel boards over the windows; doorway with pilasters; an "arched" entablature and a transom and large stone block foundation. 152 - Overhanging eaves; radiating stone voussoirs over window and door openings; boxed cornice.

Even when built in 1874 the cupola of H. Francis Dudley's house attracted notice. It is a fine flourish on a solid farmhouse that has Italianate detail in its gable-end window and front door. With its barns, sheds, and silos around it and across the street, it is an excellent example of a 19th century farmhouse.

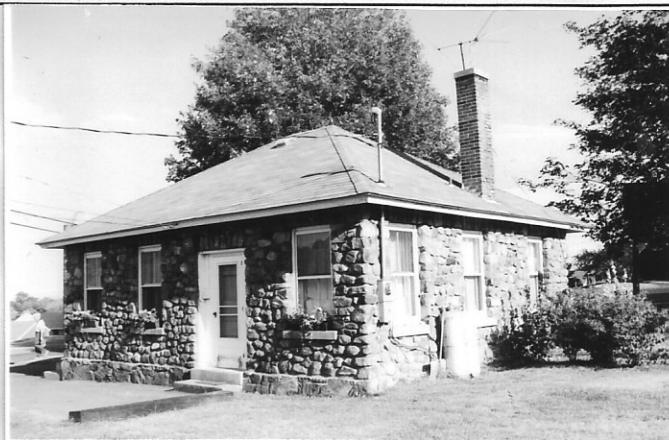
152 Tanner Marsh Road
Milk Processing Plant

No. 152. What was once a stone milk processing plant for the farm has become a house. The fieldstone walls of this building, which kept the milk cool, are its most striking feature.
