HISTORIC RESOURCES INVENTORY:
 Buildings & Structures

SURVEY OF GUILFORD, NEW HAVEN COUNTY, 06437
 June-December 1981

1. ADDRESS 197 Three Mile Course
 (map 70, lot 18)
2. NAME
 (historic) Medad Stone
 NAME
 (common)
3. USE
 (historic) See below
 USE
 (present) Private house
4. IF MOVED, WHEN AND FROM WHERE:

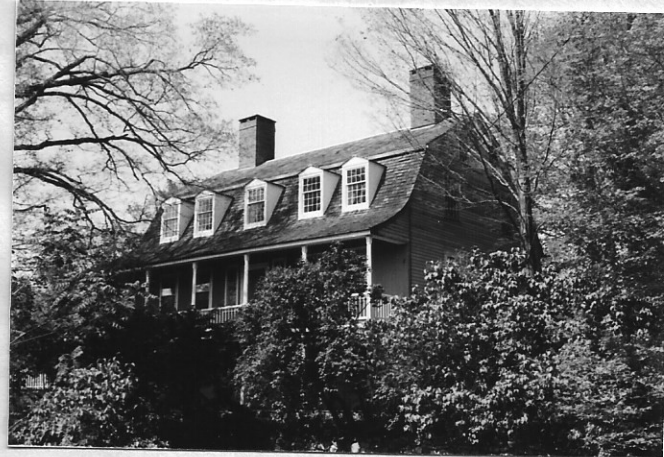
5. ARCHITECT
6. DATE 1801
7. ALTERATIONS
8. NOTABLE FEATURES
 See #9 below. Dormers appear to be original and traditionally accompany the Dutch gambrel roof as used here. 8/8 and 8/12 sash. Flushboarding on the front--a Federal touch. Stone basement.

BUILDER
 STYLE Dutch Colonial

9. ARCHITECTURAL-HISTORICAL The graceful gambrel roof sweeping out widely over the facade to form a porch is a type that evidently came to Connecticut across Long Island Sound from the Dutch settlements on Long Island, where it had been a traditional form ever since the 17th century. It was built in considerable numbers along the Connecticut coast but is almost extinct today. This house and the David Parmelee II house (68 Water Street) remain in Guilford as two fine examples. The Stone house marks the ultimate development of the style. Putting two gambrel-roofed sections together at right angles, it makes use of changes of grade to produce a complex composition unique in the New Haven region. With its porch and balconies, tall chimneys, dormers, and stone retaining walls, this is one of Guilford's most magnificent (continued on next sheet)

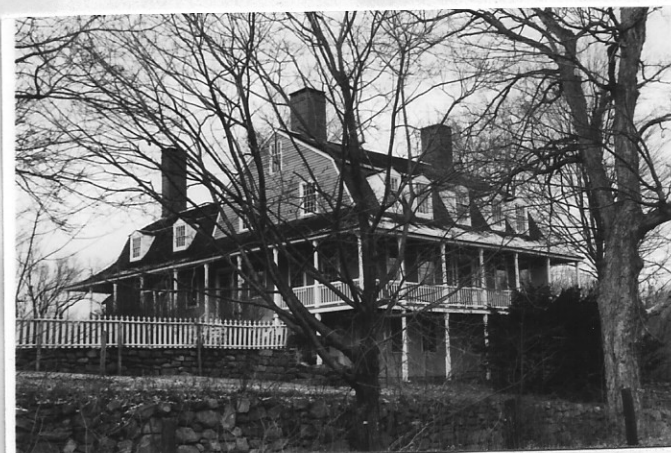
It is said that the house was added onto a year or two after it was built when a stage route was projected through here and Stone's son-in-law decided to turn the house into an inn (Medad himself was running a stage house in town, then or slightly later). But the route was changed, and the inn never opened.
