HISTORIC RESOURCES INVENTORY:
Buildings & Structures

SURVEY OF GUILFORD, NEW HAVEN COUNTY, 06437
June-December 1981

1. ADDRESS 37 Union Street
(map 40, lot 89)
2. NAME
(historic) Joseph Clay
NAME
(common) The Acadian House
3. USE
(historic)
USE
(present) Private house
4. IF MOVED, WHEN AND FROM WHERE:

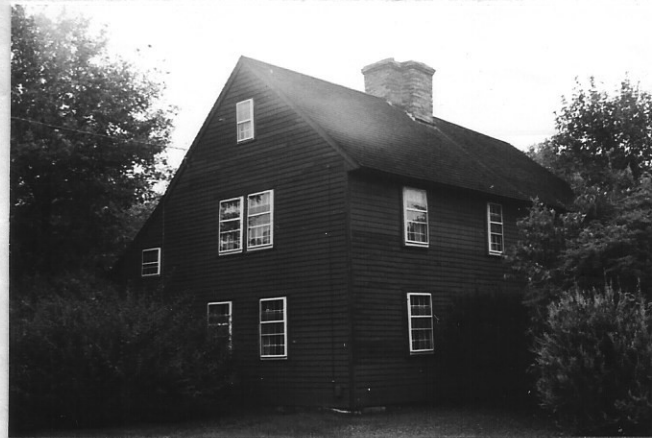
8. NOTABLE FEATURES Five window facade; asymmetrical door placement; overhanging eaves; T-shape chimney; 8/12 sash; protruding window frames; stone foundation and a wide board covering the sill.

9. ARCHITECTURAL-HISTORICAL The Joseph Clay or Acadian house is so important as evidence of 17th century building techniques that architectural histories regularly refer to it. The five windows of its facade are irregularly spaced. The addition of the lean-to to this two room deep house is marked by a change in roof slope. A T-shaped chimney crowns the house. It is an outstanding example of Guilford's early architecture.
