HISTORIC RESOURCES INVENTORY:
Buildings & Structures

SURVEY OF GUILFORD, NEW HAVEN COUNTY, 06437
June-December 1981

1. ADDRESS 56 Union Street
(map 40, lot 106)
2. NAME Darius Collins
(historic)
NAME (Milo Cook)
(common)
3. USE
(historic)
USE Private house
(present)
4. IF MOVED, WHEN AND FROM WHERE:

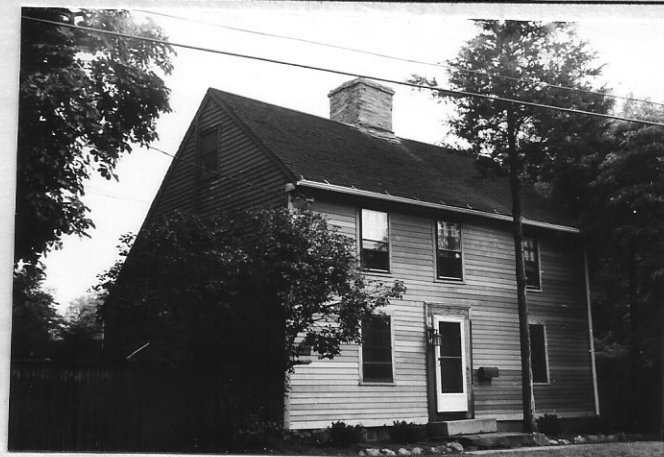
5. ARCHITECT
6. DATE 1769 BUILDER STYLE Colonial
7. ALTERATIONS
West side addition; rear addition with modern dormers; rear roof line altered; 6/6 sash.
8. NOTABLE FEATURES
Boxed cornice with a moulding below the eaves; simple moulding around the door frame; stone chimney.
9. ARCHITECTURAL-HISTORICAL
The Darius Collins house, nearly a hundred years later than its neighbor at 37 Union Street, also has an off-center five-window facade. The roof-line runs smoothly, perhaps indicating a lean-to that was integral to this one-room plus lean-to house from its origins. A simple moulding frames the doorway of this Colonial house.
