**HISTORIC RESOURCES INVENTORY:**  
Buildings & Structures

**SURVEY OF GUILFORD, NEW HAVEN COUNTY, 06437**  
June-December 1981

1. ADDRESS 90 Union Street  
(map 40, lot 110)
2. NAME  
(historic)  
NAME  
(common)
3. USE  
(historic)  
USE  
(present) Private house
4. IF MOVED, WHEN AND FROM WHERE:

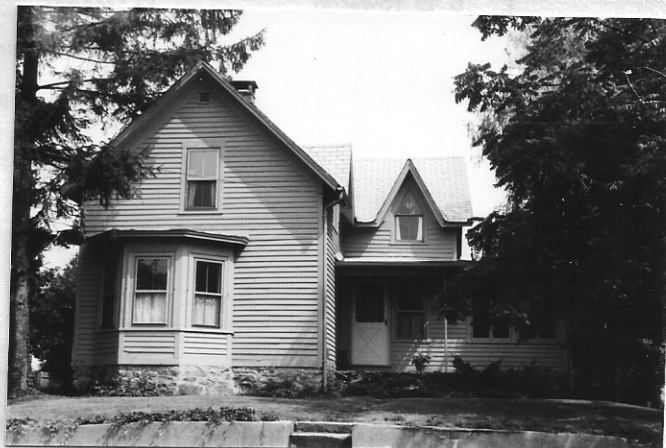
GLFD<sup>o</sup> NEG 14:22

5. ARCHITECT
6. DATE c1878 BUILDER STYLE 19th Century Vernacular
7. ALTERATIONS Enclosed porch; front bay window; and possibly the east wing.
8. NOTABLE FEATURES Pointed gable windows; quatrafoil design in porch frieze; stone foundation.

9. ARCHITECTURAL-HISTORICAL Peaked dormers are signs of the Gothic Revival influences in this one-and-a-half story house and may be a later alteration along with the enclosed porch, bay window and east ell. An article in the May 23, 1878 Shore Line Sentinel states that Henry Norton built a new house at Union and Pearl Street. The 1881 Birdseye view of Guilford shows a simply "box" shaped house at this location. However, no link has been proven between the present house at this location and the house built by Henry Norton.
