HISTORIC RESOURCES INVENTORY:
Buildings & Structures

SURVEY OF GUILFORD, NEW HAVEN COUNTY, 06437
June-December 1981

- POINT
1. ADDRESS 39 Vineyard ~~Place~~ Road
(map 2, lot 35)
 2. NAME D. Spencer Berger
(historic)
NAME
(common)
 3. USE
(historic)
USE Private house
(present)
 4. IF MOVED, WHEN AND FROM WHERE:

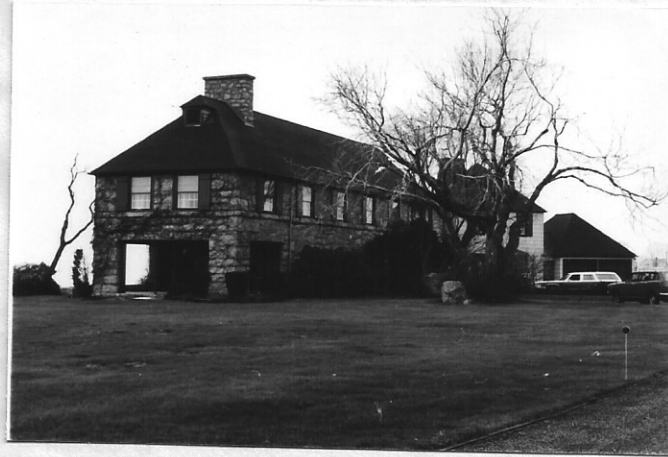
GLFD'S NEG. 21:2

5. ARCHITECT Douglas Orr
6. DATE 1932
- BUILDER
STYLE Norman
7. ALTERATIONS House winterized, remodeled with additions by Frank Winder (Orr, Winder and Associates). He also designed the boathouse.
8. NOTABLE FEATURES Steep hip roof; large stone chimneys; circular windows on the north side; patio area below the second story on the east side, supported by large stone piers.

9. ARCHITECTURAL-HISTORICAL Built by New Haven architect Douglas Orr for D. Spencer Berger, a corset manufacturer in New Haven. this house shows French Provincial influences in its long hip-roofed form. Its rough stone surface, standing in contrast to its smooth lawns, fit its site at the end of Vineyard Point, from which it has a commanding oversight on the Sound.
D. Spencer Berger purchased property on July 17, 1923 from "the Newhall sisters" with the plan to develop a summer colony with community beach and tennis court. He built a cottage for himself on the Western shore point. This cottage burned in 1931 and was replaced by the present house. Most of the neighboring cottages were built in the mid-1920s. House has been remodeled, boathouse has been added. The stone is Leete's Island Quarry Granite.
