HISTORIC RESOURCES INVENTORY:
Buildings & Structures

SURVEY OF GUILFORD, NEW HAVEN COUNTY, 06437
June-December 1981

1. **ADDRESS** 129 Water Street
(map 32, lot 17)
2. **NAME** Leete's Island Trolley Barn
(historic)
NAME
(common)
3. **USE** Shore Line Electric Railway
(historic) Car Barn
USE
(present) Manufacturing - Leeds Con-
veyor Co.
4. **IF MOVED, WHEN AND FROM WHERE:**

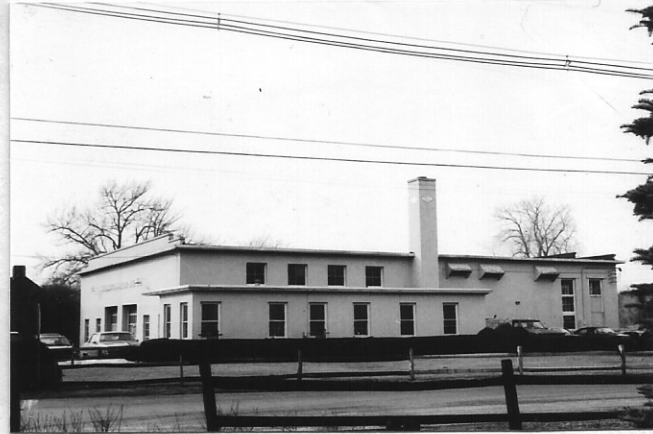
GLFD: NEG. 23:1A

5. **ARCHITECT**
6. **DATE** c1910
- BUILDER** Sperry Construction Co.
STYLE Commercial
7. **ALTERATIONS**
Side addition.
8. **NOTABLE FEATURES**
Stepped parapet.

Trolleys rolled into this two-track barn through the doors in this smooth facade, surmounted by a stepped parapet. Set more than a trolley length back from the street, this low, rectangular block, now a factory producing conveyors, is a discreet neighbor in a residential neighborhood.
