HISTORIC RESOURCES INVENTORY:
Buildings & Structures

SURVEY OF GUILFORD, NEW HAVEN COUNTY, 06437
June-December 1981

1. ADDRESS 30 Water Street
(map 32, lot 50)
2. NAME
(historic) Increase Pendleton
NAME
(common)
3. USE
(historic)
USE
(present) Private house
4. IF MOVED, WHEN AND FROM WHERE:

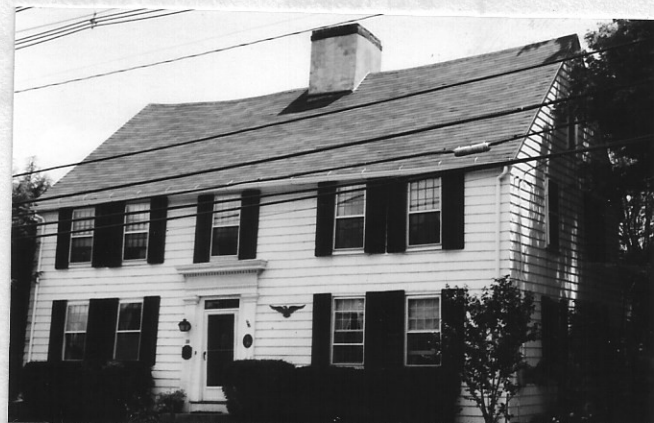
GLFD's NEG 10:34

5. ARCHITECT
6. DATE 1765 BUILDER
STYLE Colonial
7. ALTERATIONS
Shingle siding; concrete faced foundation; chimney; Greek Revival doorway.
8. NOTABLE FEATURES
Asymmetrical facade; 12/12 sash

9. ARCHITECTURAL-HISTORICAL
The asymmetrical facade of this house may be evidence of an early addition to a "half house". The Greek Revival doorway has a row of dentils along the cornice and a five pane transom light.
