HISTORIC RESOURCES INVENTORY:
Buildings & Structures

SURVEY OF GUILFORD, NEW HAVEN COUNTY, 06437
June-December 1981

1. ADDRESS 151 Whitfield Street
(map 33, lot 96)
2. NAME
(historic)
NAME
(common)
3. USE
(historic)
USE
(present) Private house and
apartment
4. IF MOVED, WHEN AND FROM WHERE:

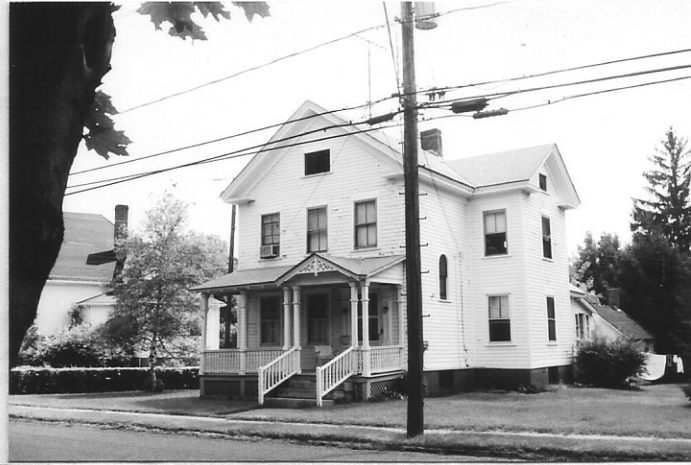
5. ARCHITECT
6. DATE c1890
7. ALTERATIONS
- BUILDER
STYLE 19th century eclectic

8. NOTABLE FEATURES
Arched staircase window with stained glass; two-story bay window;
porch with scroll work in the gable; decorative shingles.
9. ARCHITECTURAL-HISTORICAL
This house is a mixture of styles. The cornice returns, rectangular
gable windows and three bay facade are reminiscent of the Greek
Revival style that was prevalent in Guilford. The two story bay
window and the arched stair window show the influences of the
Italianate period. Decorative shingles and the scroll work in the
gable peak and the pierced boards between the balusters on the porch
are influences of the Queen Anne period.
