HISTORIC RESOURCES INVENTORY - BUILDING AND STRUCTURES

Building Name (Common) 173 Whitfield Street
 Building Name (Historic) Captain Eli Kimberly House
 Street Address or Location 173 Whitfield Street
 Town/City Guilford Village _____ County New Haven
 Owner(s) Szydlo and Francis E. Platt Estate c/o Joseph and Natalie Estof Public Private

Style of building Greek Revival Date of Construction 1850 (Helander)

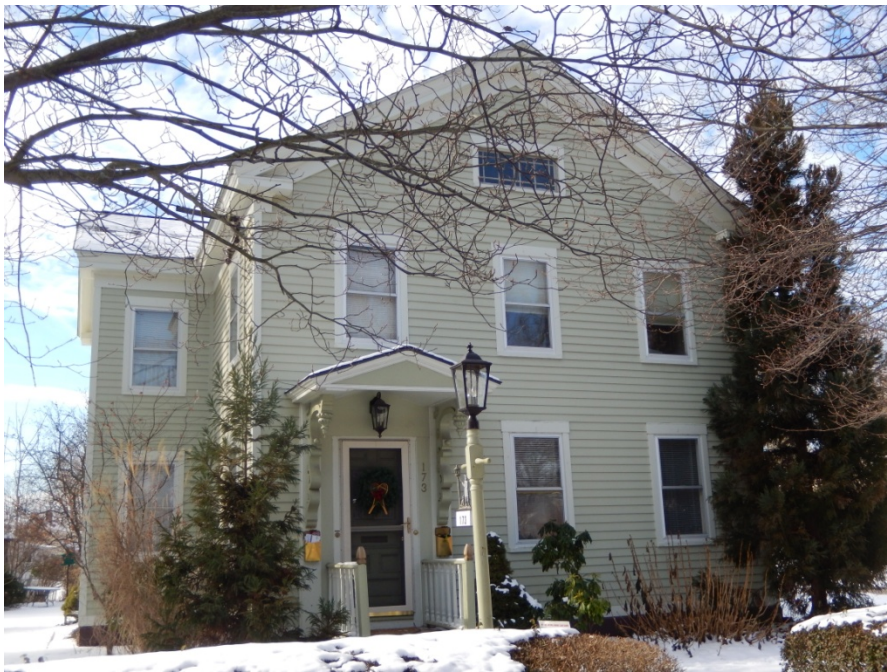
Photographer Jordan Sorensen Date 1/11/2015

View Northeast, camera facing southwest Negative on File _____

A fixed rectangular window is located near the wide trim at the peak of the roof while three one over one hung sash windows are on the second level under the cornice return, and two on the first next to the front entry. The front entry is located on the south side of the front elevation. It is located underneath a gable roof attached with decorative brackets with a small white railing on either side.
