HISTORIC RESOURCES INVENTORY:
Buildings & Structures

SURVEY OF GUILFORD, NEW HAVEN COUNTY, 06437
June-December 1981

1. ADDRESS 21 Whitfield Street
(map 39, lot 100)
2. NAME
(historic) Dan Collins
NAME later Amos Seward
(common) Greene Gallery
3. USE
(historic) Private house
USE Shop and apartment
(present)
4. IF MOVED, WHEN AND FROM WHERE:

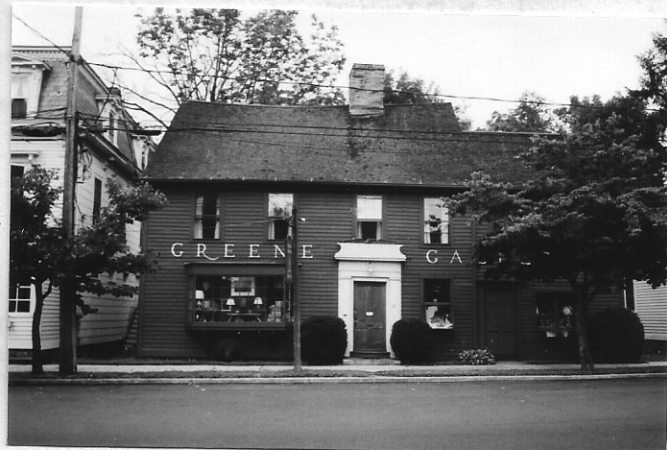
5. ARCHITECT
6. DATE 1772
7. ALTERATIONS North side addition; front bay window; 6/6 sash; Greek Revival doorway.
8. NOTABLE FEATURES Stone chimney; asymmetrical facade.

9. ARCHITECTURAL-HISTORICAL The off-center chimney and doorway of this Colonial house are among the features that show a building adapted to the needs of its many inhabitants. The addition of a Greek Revival doorway to an older house is typical of Guilford. The addition at the north-end is an early modification. This house, now a shop, close to the street alongside the Green, is testimony to the changing role and continued importance of the Green in the town's history.
The house was built by Dan Collins. Later it was owned by Amos Seward, the town's second postmaster, who kept the post office in a room here.
