**HISTORIC RESOURCES INVENTORY:**  
Buildings & Structures

**SURVEY OF GUILFORD, NEW HAVEN COUNTY, 06437**  
June-December 1981

1. ADDRESS 29 Whitfield Street  
(map 39, lot 98)
2. NAME  
(historic) Henry Hale House  
NAME  
(common)
3. USE  
(historic)  
USE  
(present) Doctor's office and  
apartments
4. IF MOVED, WHEN AND FROM WHERE:

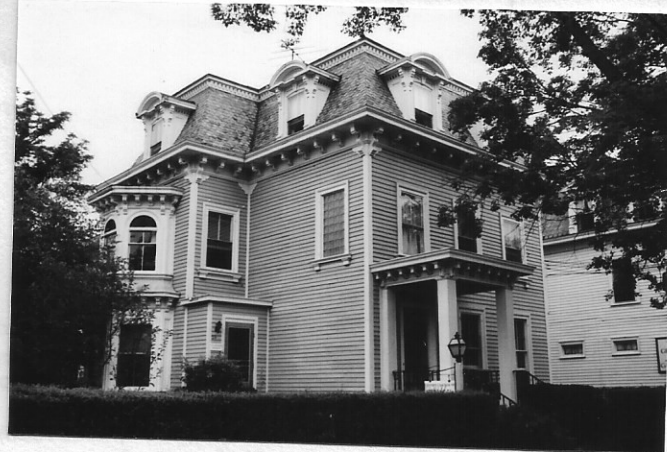
5. ARCHITECT
6. DATE 1873
- BUILDER  
STYLE Second Empire
7. ALTERATIONS  
Porch railing; rear porch with a room above; replaced sash of one window on south side second floor with glass blocks; entrance on south side.
8. NOTABLE FEATURES Slate roof; dormers with segmental pediment roofs; brackets; keystone design and dentils; wide corner boards with flat brackets at the frieze line; two story bay window with arched opening on second floor; original arched window front door; porch with square posts supporting a flat roof.

9. ARCHITECTURAL-HISTORICAL  
In the Second Empire style of the 1870s, this house was built by Henry Hale, owner of the store at no. 25. Dormers with deep luxurious trim pierce the slate mansard. The fine two-story bay, bracketed at two levels enlivens the south side of the building. Corner boards that meet the frieze of the house in a decorative flourish punctuate each corner.  
A fire in 1872 had destroyed buildings on this part of Whitfield Street, making a place on the Green for an important expression of Victorian taste, in this as well as in the buildings at nos. 25 and 33 Whitfield. Henry Hale built his house on the site of a store (owned by John Hale, no relation). Fitz-Greene Halleck, the poet, was born in an earlier building here in 1790. Physicians have maintained offices in this property for some time.
