**HISTORIC RESOURCES INVENTORY:**  
Buildings & Structures

**SURVEY OF GUILFORD, NEW HAVEN COUNTY, 06437**  
June-December 1981

1. ADDRESS 342 Whitfield Street  
(map 28, lot 31)
2. NAME  
(historic)  
NAME  
(common)
3. USE  
(historic)  
USE  
(present) Private house
4. IF MOVED, WHEN AND FROM WHERE:

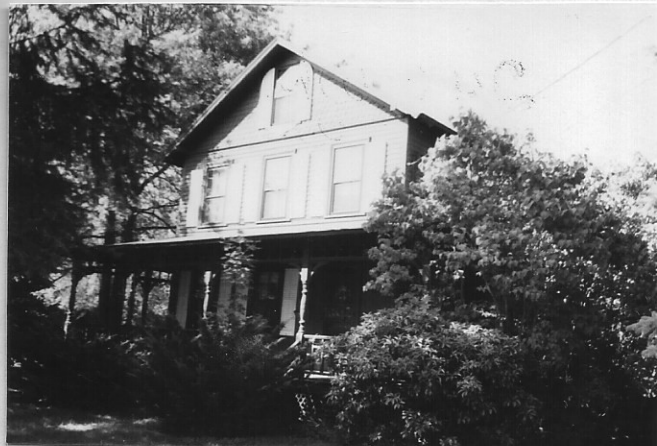
8. NOTABLE FEATURES  
Overhanging eaves and raking; rafter ends visible; modestly decorative bargeboard; fish scale shingles in the gable; 2/2 sash; wrap around porch with decorative posts.

Scalloped shingles, ornamented window frames and a delicate porch give this simple structure the charm of the Queen Anne style. This house surrounded by trees and shrubs, is a valuable contribution to a quiet street.
