**HISTORIC RESOURCES INVENTORY:**  
Buildings & Structures

**SURVEY OF GUILFORD, NEW HAVEN COUNTY, 06437**  
June-December 1981

1. ADDRESS 456 Whitfield Street  
(map 26, lot 29)
2. NAME Caleb Benton  
(historic)  
NAME  
(common)
3. USE  
(historic)  
USE Private house  
(present)
4. IF MOVED, WHEN AND FROM WHERE:

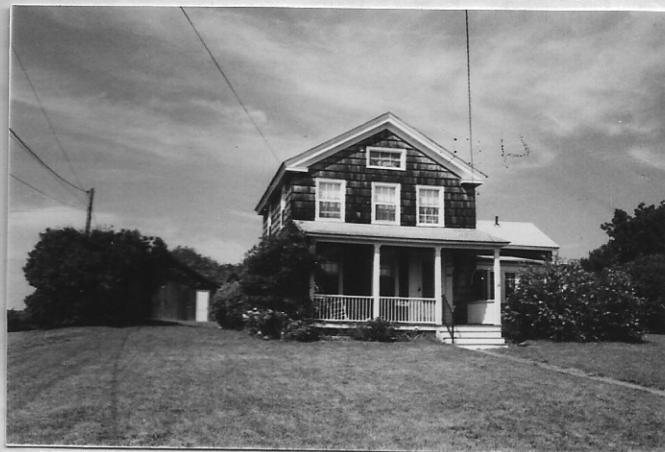
5. ARCHITECT
6. DATE 1865
- BUILDER William Weld  
STYLE Greek Revival
7. ALTERATIONS  
Shingle siding; side wing; 6/6 sash (first floor); porch (shed, roof, square columns).
8. NOTABLE FEATURES  
6/6 sash (second floor); rectangular gable window; pilasters flank the front door.

9. ARCHITECTURAL-HISTORICAL  
The Caleb Benton home is one of the sizable group of Greek Revival houses in Guilford built by William Weld. Wooden shingle is an unusual wall treatment for houses of this sort; probably early 20th century alteration. This house is a reminder of the rural heritage of this part of town from its site atop a hill.
