# HISTORIC RESOURCES INVENTORY - BUILDING AND STRUCTURES

Building Name (Common) Village Chocolatier/The Marketplace at Guilford Food Center  
 Building Name (Historic) Mousch Barber Shop/First National Store/Guilford Food Center  
 Street Address or Location 77 Whitfield Street (Sometimes referred to as 77-79)  
 Town/City Guilford Village \_\_\_\_\_ County New Haven  
 Owner(s) The Marketplace Emporium LLC  Public  Private

77 Whitfield Street

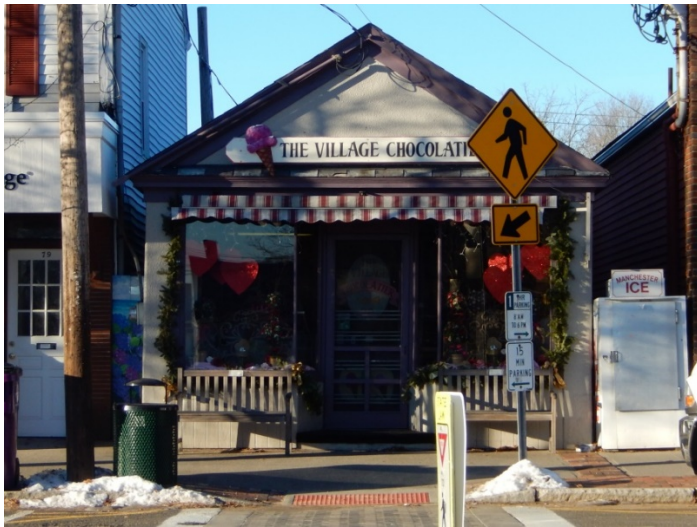
Built c. 1932, Building #1 is a small vernacular style commercial building with gray stucco siding and dark purple trim. It has a front gable roof covered in asphalt shingles. The facade has two large display windows and a recessed center door entry. Building #2, built in 1931 (Shoreline Times article), is a vernacular commercial building with a brick facade and vinyl siding on the sides. The front gable roof is covered with asphalt shingles with a louvered cupola in front. (See C.S.)

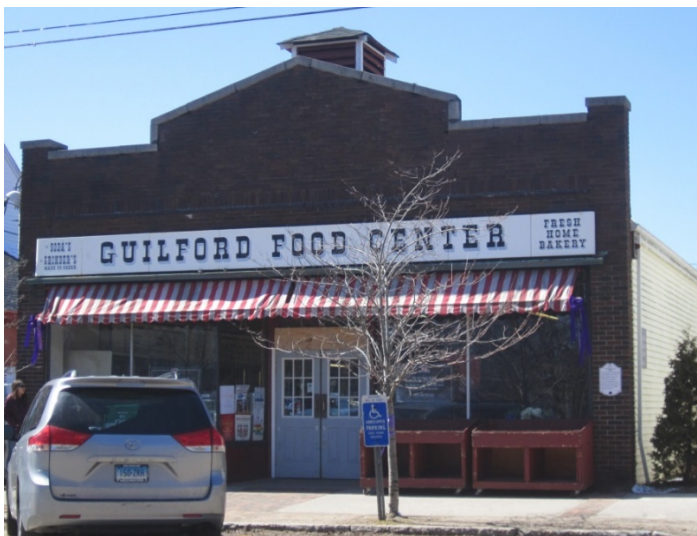
Building #2

Two castellation towers are located on either side of the façade with an elevated pediment in the middle. A full façade awning covers two large bay windows with a pair of doors in the middle.
