HISTORIC RESOURCES INVENTORY:
Buildings & Structures

SURVEY OF GUILFORD, NEW HAVEN COUNTY, 06437
June-December 1981

1. ADDRESS 85-89 Whitfield Street
(map 39, lot 89)
2. NAME
(historic) Monroe Building
NAME
(common) Monroe Building
3. USE
(historic) Shops and hotel
USE
(present) Shops and offices
4. IF MOVED, WHEN AND FROM WHERE:

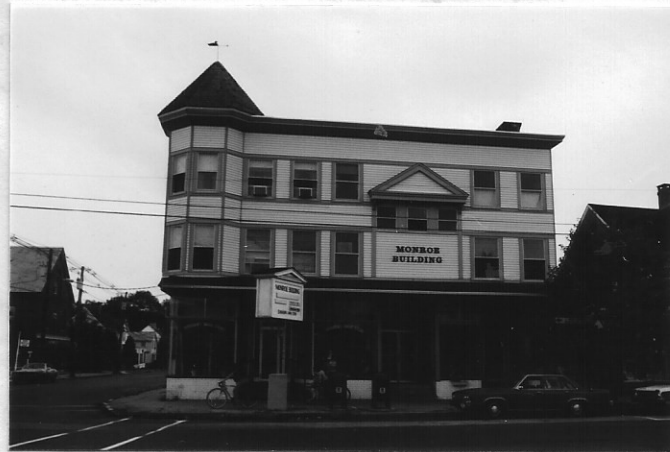
5. ARCHITECT
6. DATE 1898
- BUILDER
STYLE Queen Anne
7. ALTERATIONS
Siding; aluminium windows; store fronts.
Turret replacing original is quite different in shape, original was a variation of the onion shape. Also second story balcony removed from Whitfield Street side.
8. NOTABLE FEATURES
Wide overhanging eaves; turret; stone foundation.

9. ARCHITECTURAL-HISTORICAL The polygonal tower of this Queen Anne style commercial block dominates the south-west corner of the Green. Modern siding covers the diverse textures of the original surface.
J. Harrison Monroe, a prominent Guilford Democrat, built the "Monroe block" in 1898 to house his drug store, which he had moved from Water Street. He had bought the old hotel at the corner of Whitfield-Water Streets and part of it was incorporated in the west-wing of this building. Monroe's drug store was on the ground floor. Hotel Halleck occupied the upper floors. Markham's jewelry store rented space here until 1902. The U.S. Post Office rented part of the ground floor from 1903 until the present building was opened.
Monroe's son, Bradford, took over the business. He sold the building in 1970.
