**HISTORIC RESOURCES INVENTORY:**  
Buildings & Structures

**SURVEY OF GUILFORD, NEW HAVEN COUNTY, 06437**  
June-December 1981

1. ADDRESS 55 York Street  
Map 45, Lot 18
2. NAME  
(historic) Andrew Fowler, Sr.  
NAME  
(common)
3. USE  
(historic)  
USE  
(present) Private house
4. IF MOVED, WHEN AND FROM WHERE:

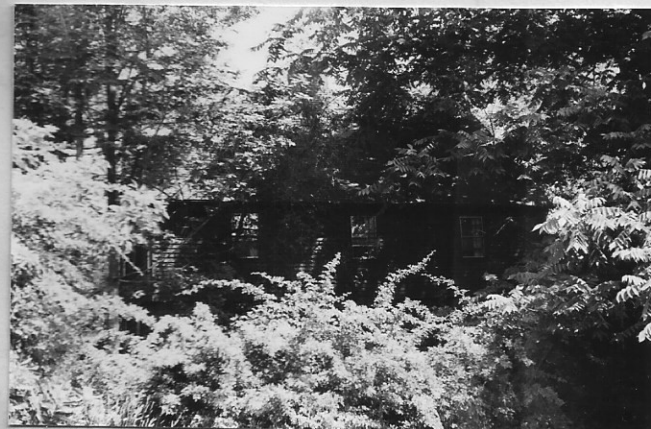
5. ARCHITECT
6. DATE 1790
- BUILDER  
STYLE Colonial
7. ALTERATIONS  
Small side addition; rebuilt chimney; aluminum storm windows

8. NOTABLE FEATURES  
Overhangs on the front and sides of the second and third stories; 8/12 sash on the second floor; 12/12 sash on the first floor; protruding window frames; seven pane transom above the double paneled doors
9. ARCHITECTURAL-HISTORICAL  
An exceptionally good example of Guilford's 18th century architecture, the Andrew Fowler house has the small windows, narrow overhangs on front and sides and an example of a doorway without Greek Revival accretions. The double door has a row of small panes above and wide boards around it, giving an impression of great size. Barn, brook, and pond complete a vision of early rural Guilford just off U.S. Route One.
